HYDRAULIC HERITAGE: QANATS AND LANDSCAPE DYNAMICS IN THE LIBERATED KARABAKH TERRITORIES

Qanat systems are traditional underground channels designed for water transportation and play a vital role in providing reliable water sources for both drinking and irrigation purposes. Over the past two years, monitoring was conducted in the territories of Karabakh liberated from occupation to assess the condition of qanats after a 30-year period. The findings revealed that many qanats still show traces of past military activities. A comprehensive study was undertaken to evaluate the technical condition and restoration potential of the qanats. In parallel, land reclamation, hydrogeological, and agro-soil investigations were carried out across the entire qanat distribution area. The results indicated that conditions varied significantly among the Agdam, Fuzuli, and Jabrayil districts. Recommendations include regular monitoring of water and soil quality, implementation of effective qanat rehabilitation methods, and the optimal utilization of qanat water for both domestic and agricultural purposes. This study emphasizes the importance of qanat systems for arid and semi-arid regions and offers pra

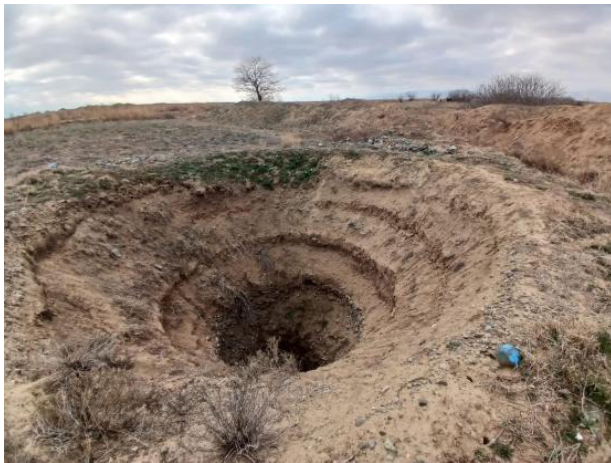
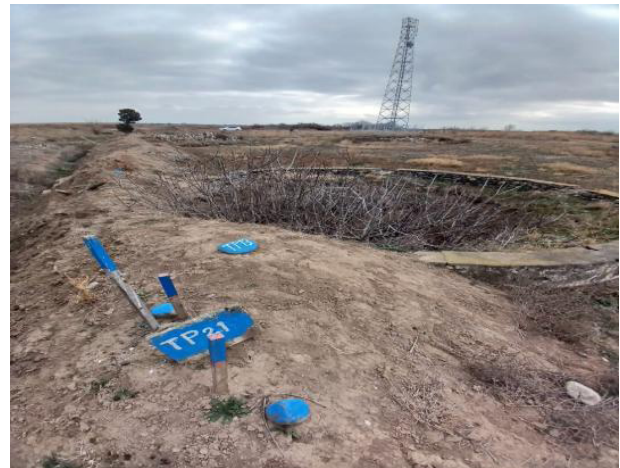
and Bash Gervend) has led to land being overgrown with various shrubs and trees. Figure 3 presents two graphs for the wells of the Mollamammadali Qanat in Bash Gervend village, Agdam District.

Wells of the Mollamammadali Kahriz located in Bash Gervend village, Agdam District.

During observations, we recorded tunnel collapses in sections of the qanat at depths of only 2–3 meters, leading to cessation of its operation. At present, an official appeal has been submitted to the authorities regarding the activities of the construction companies. Despite our appeals to the relevant authorities, no conclusions or actions have been taken so far.

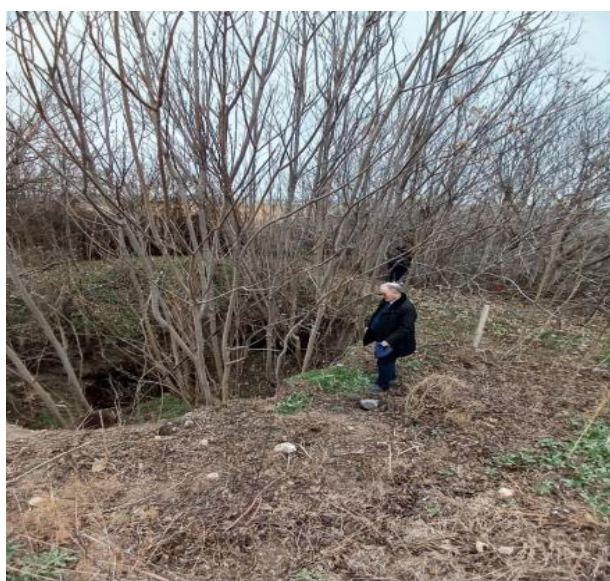
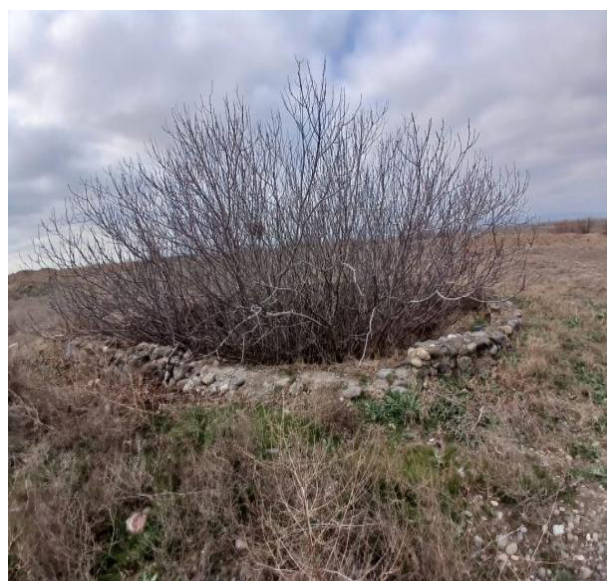
Figure 4

Outlets of the Karasu (a) and Mollamammadali (b) Qanat wells in Bash Qervend village.
